IMPORTANT SAFETY RECALL

NHTSA Safety Recall No. 18V-138

Customer Service Notice

Upper Boom Fiberglass Inspection

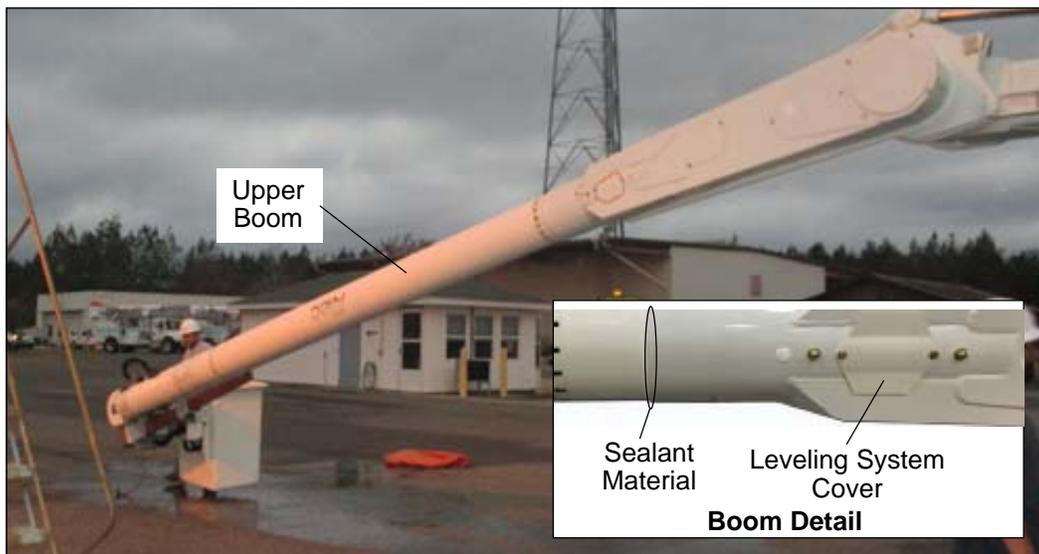
Figure 1 — Upper Boom Position

1. Position the unit on a level surface, apply the parking brake and chock the wheels. Engage the unit's hydraulic system. Properly set the outriggers.
2. Perform the Preoperational Inspection from the unit Operator's Manual. Note any problems and make any corrections necessary.
3. Operate the unit from the lower controls and position the unit with the upper boom in the overcenter position with the platform about one foot from the ground in order to gain access to the fiberglass to steel interface (refer to Figure 1).

4. Remove the cap screws attaching the leveling system access cover on the upper boom weldment (refer to Figure 1).
5. Use a putty knife or similar tool to remove all sealant material around the outside of the fiberglass to steel joint, taking care not to damage the fiberglass (refer to Figure 1). The sealant that is used to seal the steel to fiberglass interface **MUST** all be removed to allow maximum visibility of the joint.

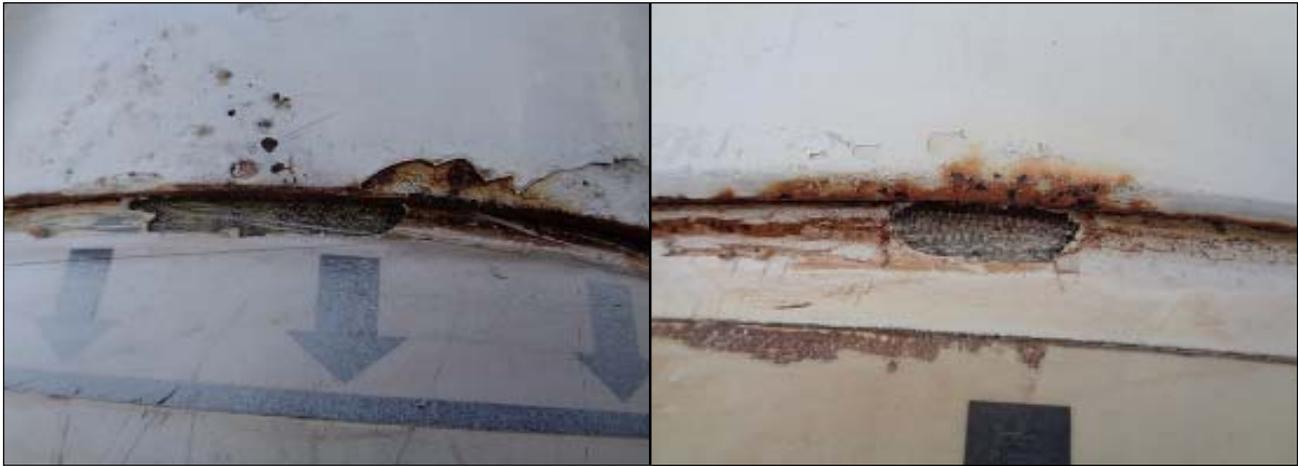
Figure 2 — Examples Of Gelcoat Damage

7. Inspect the area where the fiberglass joins to the steel boom for any cracks or damage including broken, bubbled, or flaking gelcoat (refer to Figure 2).

8. If the fiberglass gelcoat is scratched, but not damaged, continue to Step 9. If any fiberglass gelcoat is damaged, remove the unit from service immediately and go to Step 19.

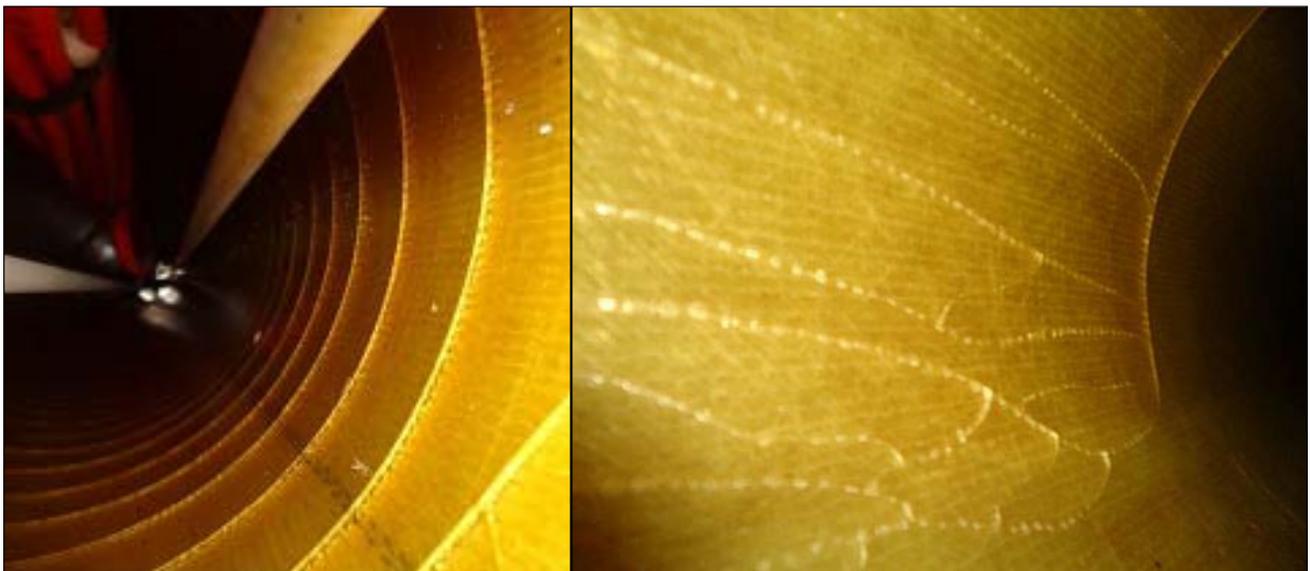
Figure 3 — Inside Boom (representative cracks shown)

10. Use a scope, camera, or similar method to closely examine the inside of the boom near the fiberglass to steel joint. While doing the inspection look for any of the following (refer to Figure 3).

- cracks
- spots of resin discoloration
- any other abnormalities which could represent fiberglass damage

11. If there are any cracks, internal or external, chipping, or other signs of fiberglass damage near the fiberglass to steel joint, remove the unit from service immediately and go to Step 19.
12. With the unit still in the overcenter position and the platform no more than one foot from the ground, have a second person standing on the ground at the platform quickly push up and down on the platform (maximum force of 150 lbs) in order to “bounce the boom” slightly. As the second person bounces the boom up and down, inspect the fiberglass to steel joint area around the entire boom for any signs of cracking in the gelcoat or fiberglass. The cracks may be small (refer to Figure 4). Also look for any signs of excessive motion at the fiberglass to steel joint.
