Heartland Front Reflector

Description

Inspection & Repair

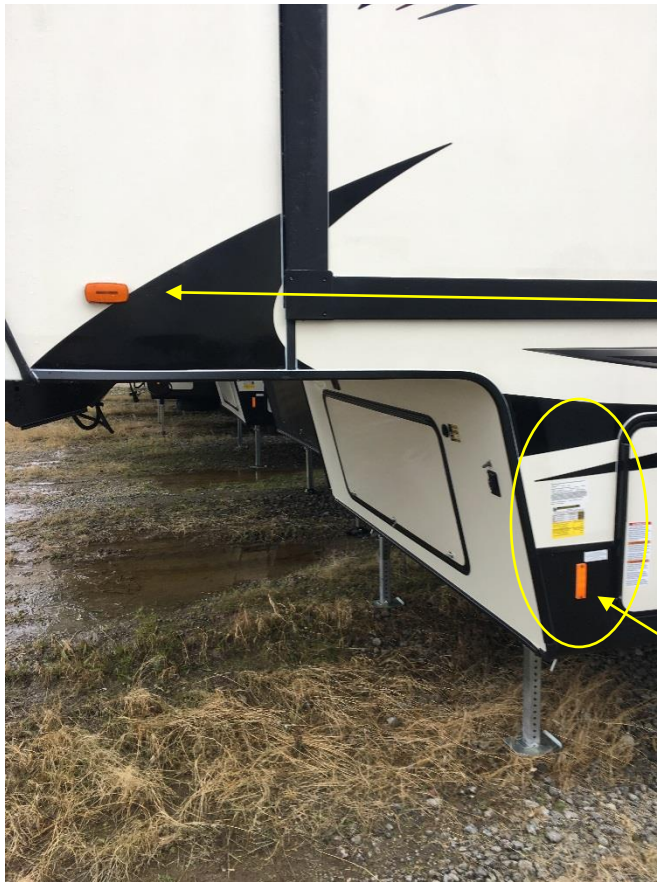
1. This is the correct locations of the reflector and side marker light on the fifth wheel.

Forward Side marker light
located on both side walls

Forward Sidewall reflector
should be mount in this location.
On both sidewalls.

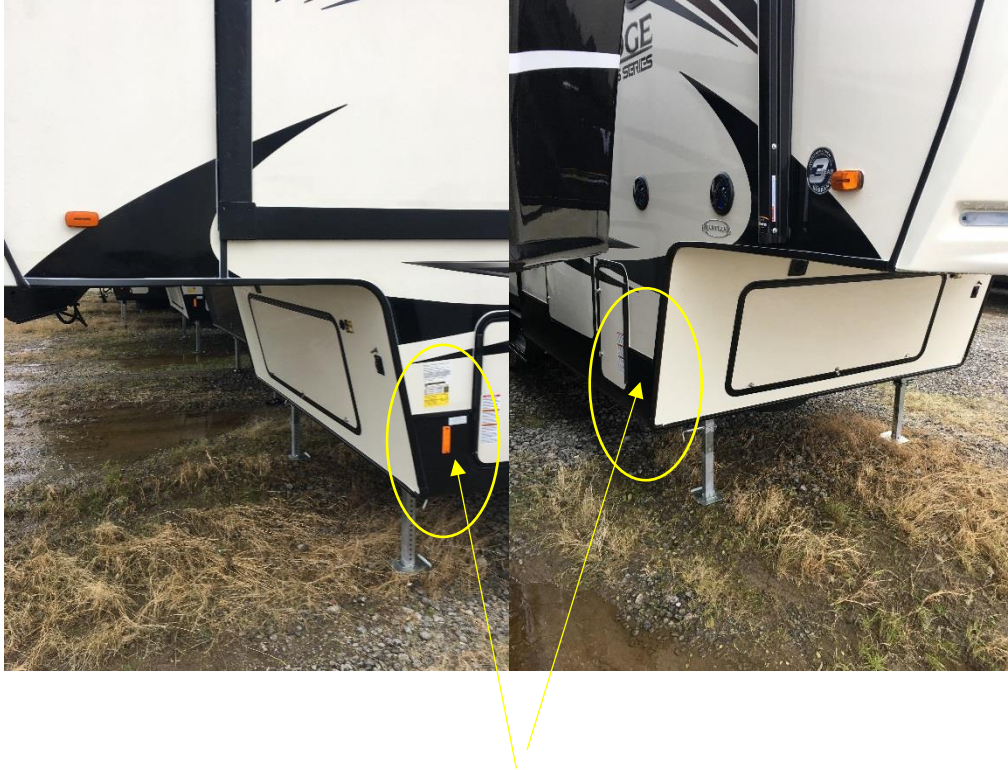
2. Where to install the reflector that is being sent to you.

3. Location to install the reflector, place one on each side (preferably on the skirting) any position in this general area is acceptable as long as the reflector is below 60"
4. Clean any dirt from the sidewall, peel backing from tape and apply. Screws can be applied for additional strength.
